Summa Four, Inc., 25 Sundial Avenue, Manchester, New Hampshire 03103

Technical Bulletin #: TM-C1-0158
Date Issued: October 7, 1997
Audience: Integrated SS7 Customers
Product(s) Affected: Integrated SS7 Systems
Distribution: ___ - Critical X - Standard ___ - Special

Purpose of Bulletin

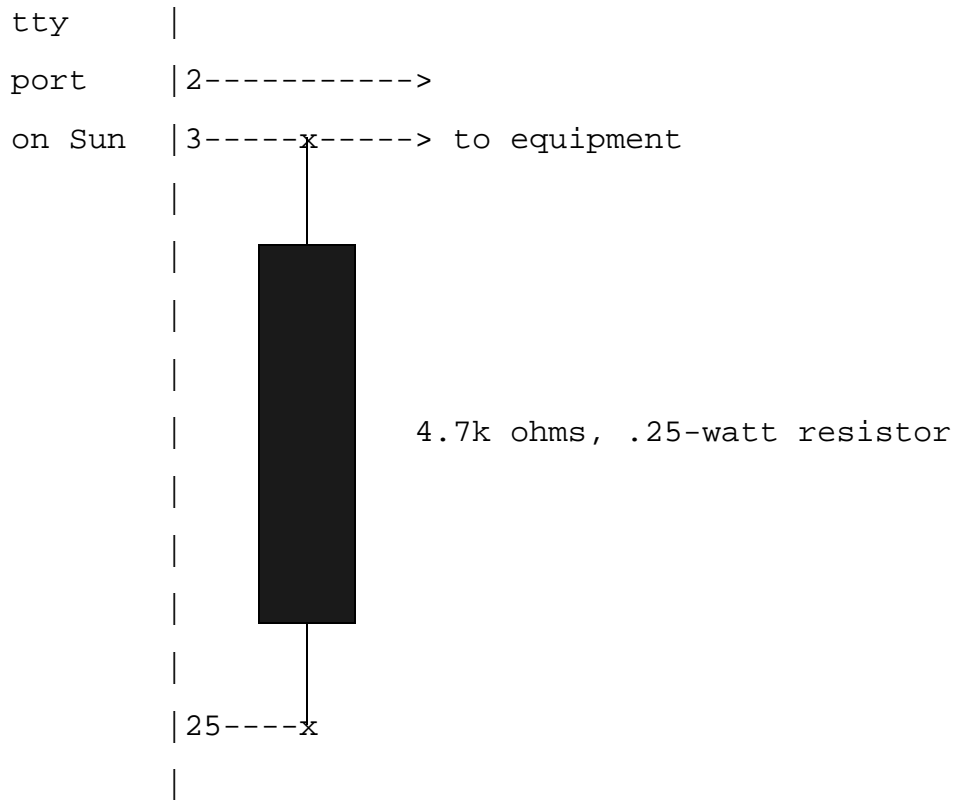
2. Apply a cable fix that uses a resistor between two pins of the serial cable—a 4.7k ohms, .25-watt resistor between pins 3 and 25. Then, reconnect the VT terminal.
