**SDS/VCO Generic
Release Notes Addendum
V4.2 FSR00 PUN 26**

63103950142-0BR

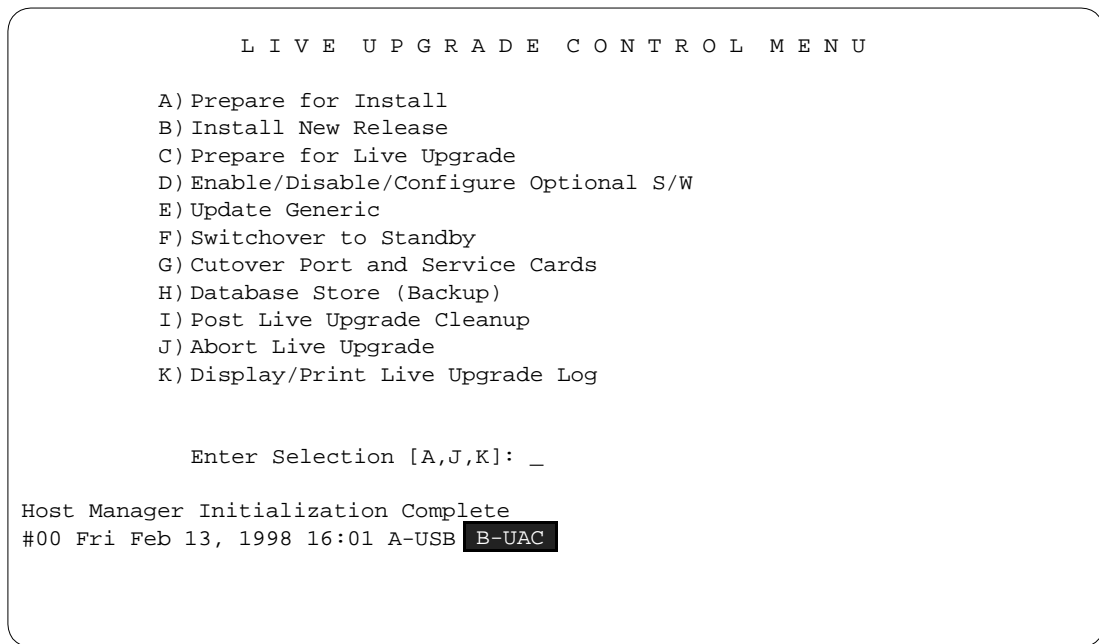
TP000159

The Live Upgrade Control Menu is illustrated in Figure 3.2. Valid selections are limited to those appropriate for the current step as indicated in brackets "[]". For example, "Enter Selection [A,J,K]:".

Figure 3.2: Live Upgrade Control Menu

To indicate that a live upgrade is in progress, the field displays UAC or USB. UAC indicates UpgradeActive mode, and USB indicates UpgradeStandBy mode. In Figure 3.2, side A is in standby mode and side B is active.

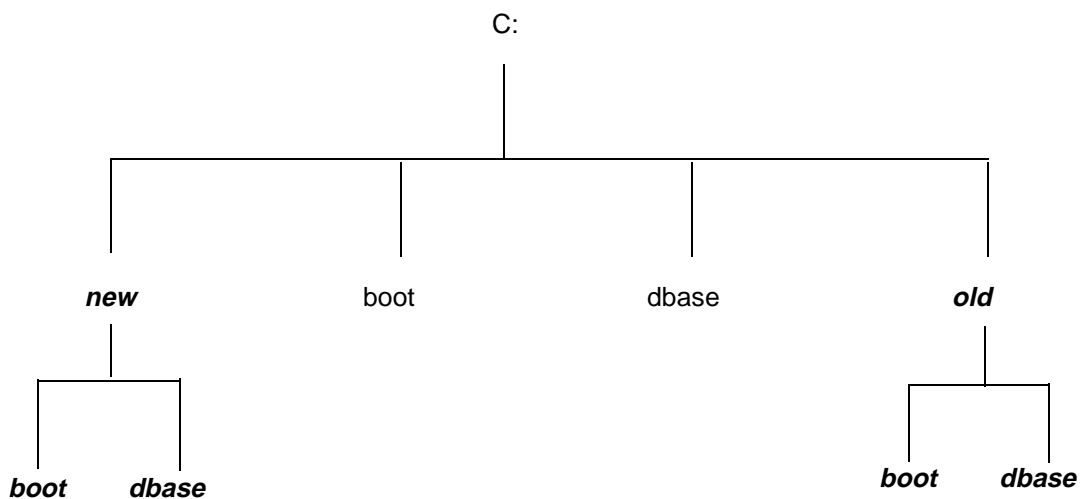
The directory structure that is required by the upgrade process is shown in Figure 3.3. The directories created for the upgrade procedure are shown in bold italic; they are automatically created by the Generic software automatically when you choose the Prepare for Install option. If they already exist, any existing files in these directories are deleted, but the directories themselves are maintained, for use during the upgrade process.

Figure 3.3: Directory Structure

Directory	Contents
C:/new/boot	New executable files, and download application files
C:/new/dbase	New, empty database
C:/old/boot	Current software release The current Generic software is restored from this directory if the Abort Upgrade option on the Live Upgrade Control menu is selected.
C:/old/dbase	Current database The current database is restored from this directory if the Abort Upgrade option on the Live Upgrade Control menu is selected.

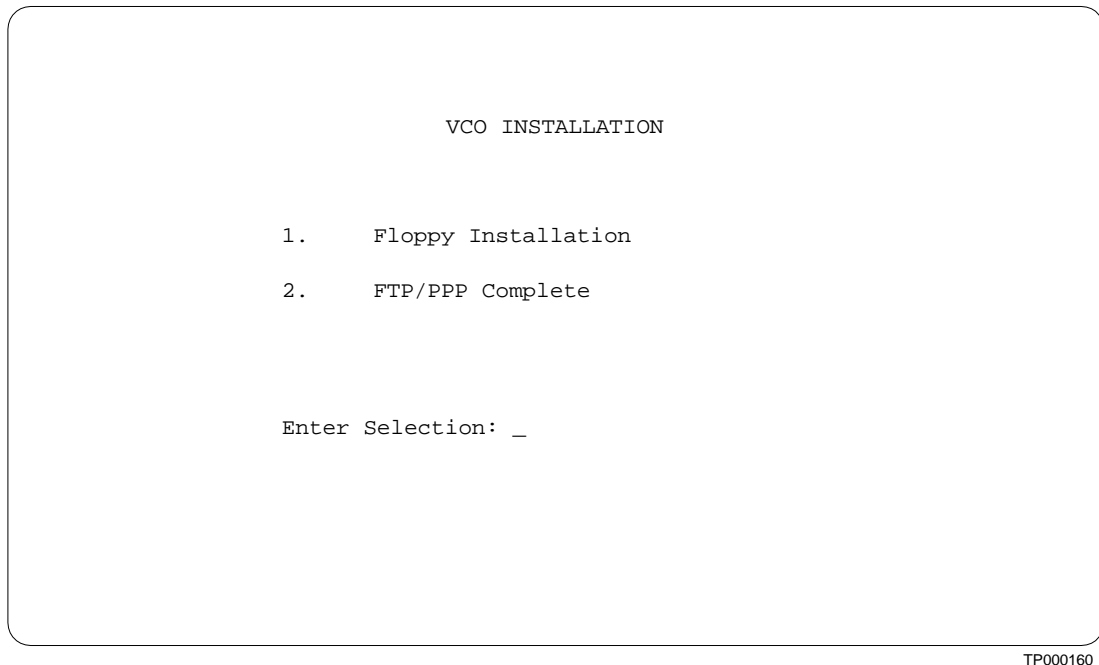
When you choose the Install New Release option on the Live Upgrade Control menu, the VCO Installation screen is displayed as shown in Figure 3.4.

Figure 3.4: VCO Installation Screen

When the transfer of the new generic software to the hard disk using FTP is complete, you must indicate that the transfer is complete by selecting option 2 in the VCO Installation screen; refer to Figure 3.4 on page 19. The generic software then verifies that the transfer is complete. Successful transfer is indicated by the message: Check for all Files Successful.

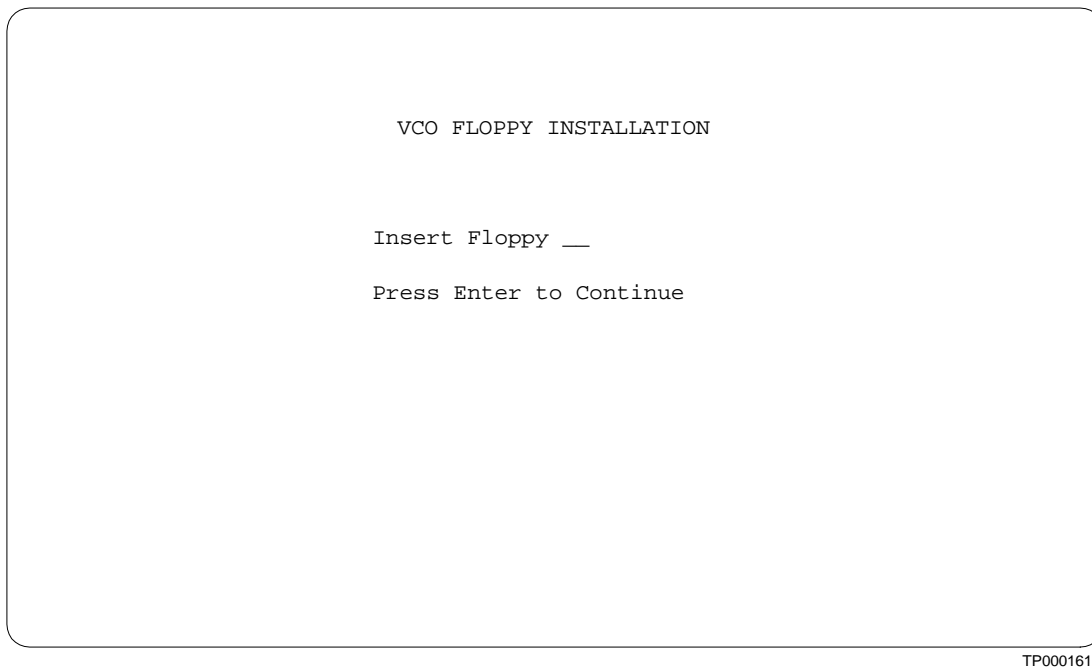
To install from floppy disks, choose option 1. The VCO Floppy Installation screen is displayed; refer to Figure 3.5.

Figure 3.5: VCO Floppy Installation Screen

When you choose the floppy installation option you are prompted to insert the installation disks into the floppy drive so that the files can automatically be transferred into the appropriate directories. Pressing any key other than Enter or Return stops the loading of files from the floppy drive.

The floppy disk number is displayed in the VCO Floppy Installation screen; for example, Insert Generic Floppy 1. When the floppy is inserted the volume label is verified. Your response (for example, if you pressed the Enter key to continue) is logged in the upgrade log file along with the files that are being installed. If any files are missing from the floppy, or if there is a mismatch, the upgrade is aborted.

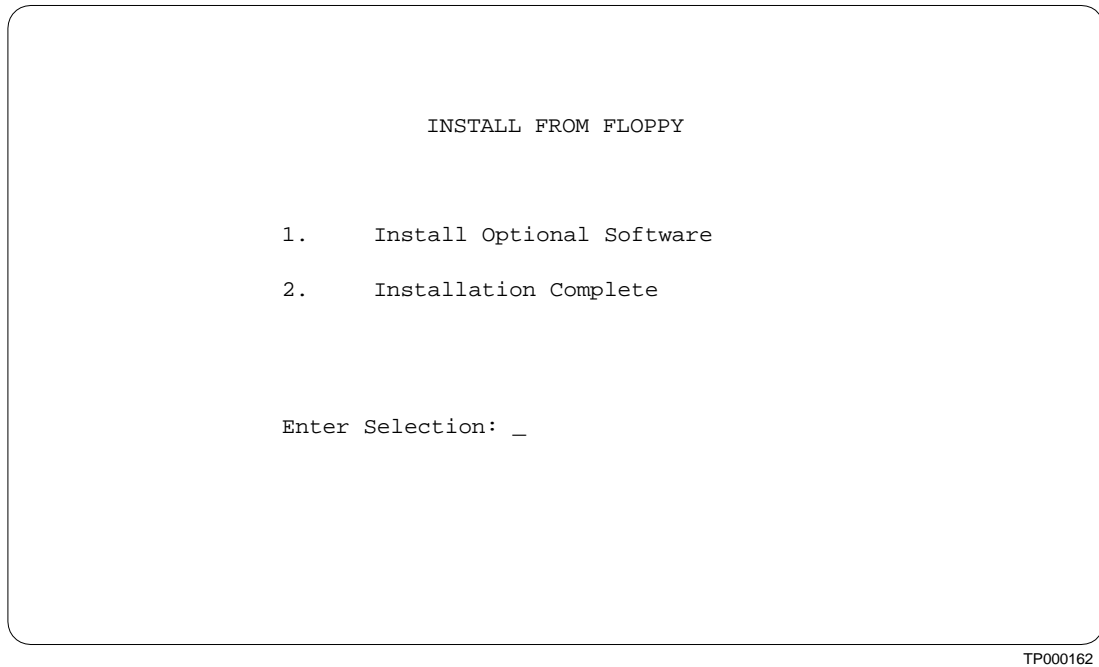
After all software disks have been installed, you are prompted to install optional software from the screen as shown in Figure 3.6. If no other software is to be installed, select option 2 as shown in Figure 3.6, and press the Enter key to exit the installation.

After the Generic software is installed, you can install optional software package files; refer to Figure 3.6.

After completing the installation of an option, the menu in Figure 3.6 appears again. Select option 1 again to install another software package, or select option 2 to terminate the installation.

Figure 3.6: Install from Floppy Screen

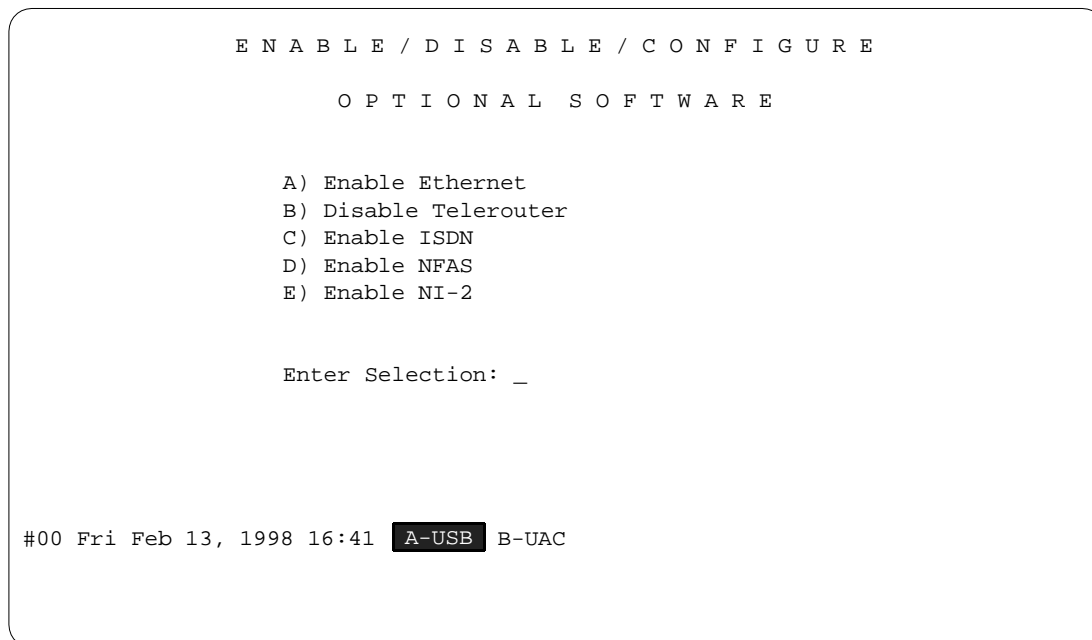
TP000163

To initiate step 9, choose option D. The screen illustrated in Figure 3.8 is displayed.

Note that only the optional software packages that have been installed are shown.

This step consists of two parts: enabling the options and configuring the options.

Figure 3.8: Enable/Disable/Configure Optional Software

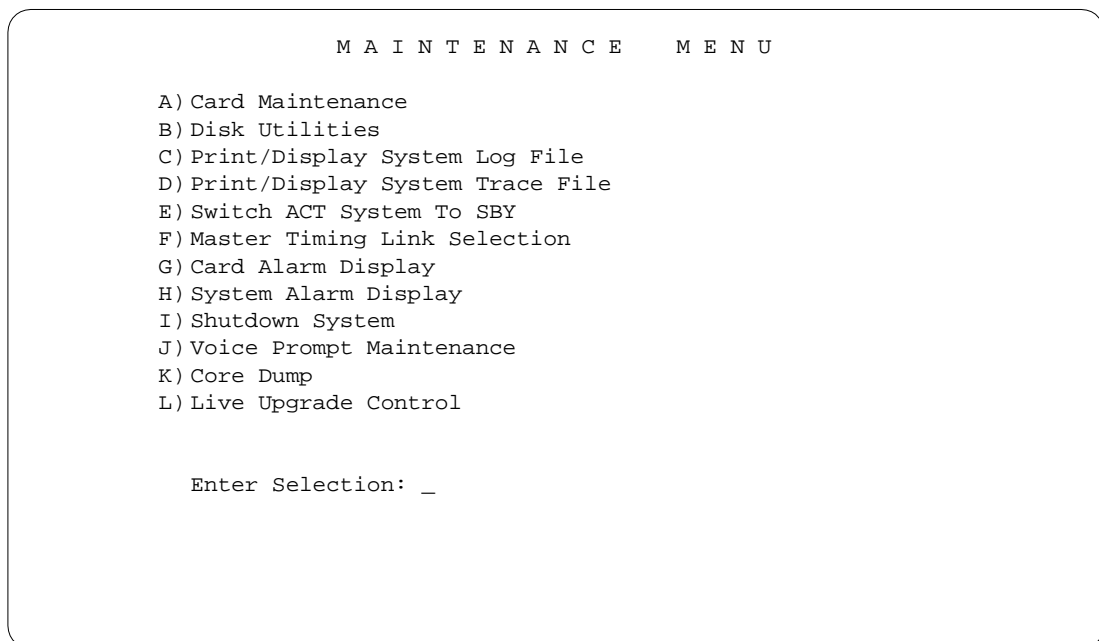
TP000072

1. Sign onto the system and access the Maintenance menu. (Refer to Figure 3.10)

Figure 3.10: Maintenance Menu

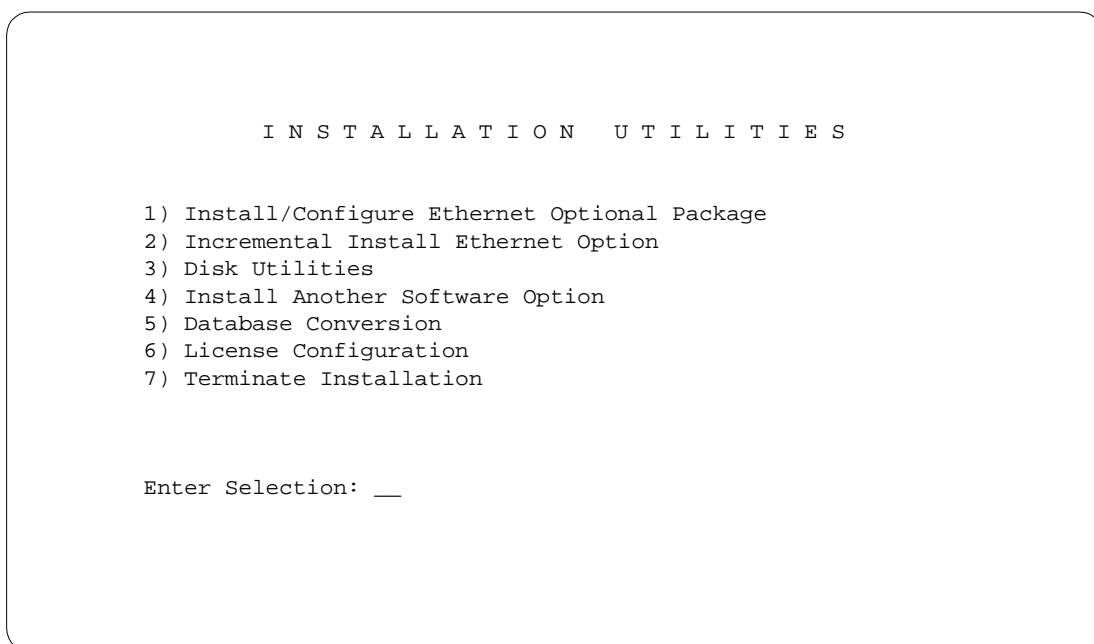
TP000122

Figure 3.12: Installation Utilities Menu

When the installation is complete, the Installation Utilities menu appears again (*Figure 3.12*).
11. Optional software needs to be installed every time you update the Generic to ensure NVRAM update. For options such as TeleRouter, ISDN-NFAS, or Ethernet, type **4**, Install Another Software Option, then press **Return**.

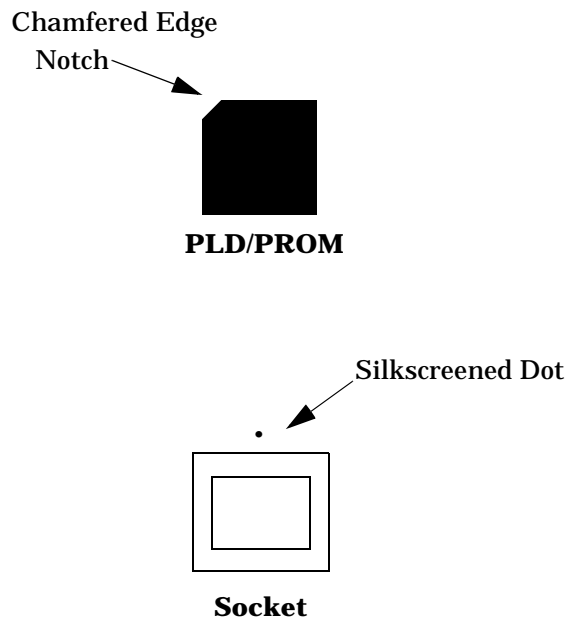
1. Before installing the new PLD, verify that the pins are all evenly spaced and properly aligned. If necessary, use tweezers to carefully align the IC pins prior to installation.
2. Align the notch or chamfered edge on the PLD to the silkscreened dot on the circuit card (see Figure A.5).

Figure A.5: PLD Alignment

3. With all pins aligned to the pins of the socket, apply gentle, even finger pressure to the top of the chip until it is fully seated in its socket. This completes the installation of the surface mount chip.
4. Reinstall the circuit card in the system or return the card to spares stock.
