**Generic Release Notes  
V3.3 FSR06 PUN 38**

61040300633-0DR

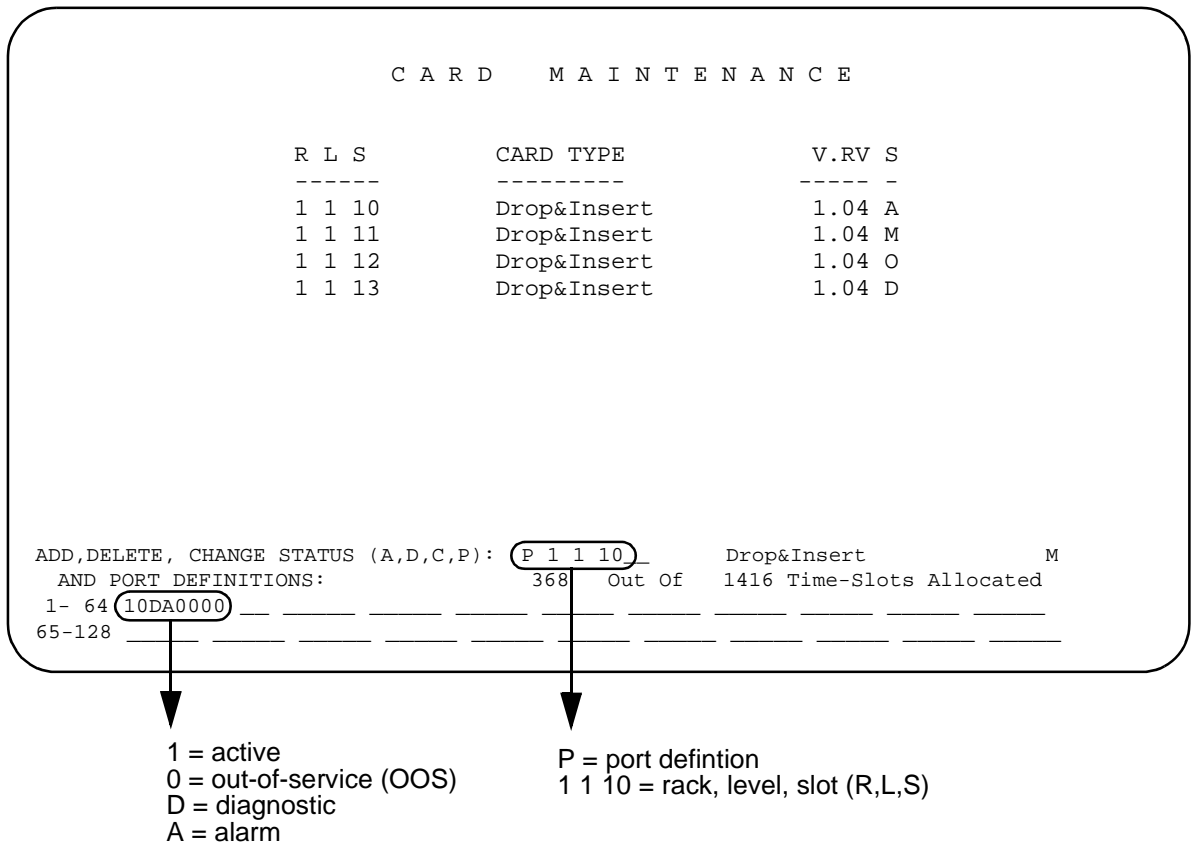
Figure 1.4: Card Maintenance Screen

In Figure 1.4, the ports on the D&I card in (R,L,S) 1-1-10 are in the following modes:

- Port 1—active mode
- Port 2—out of service
- Port 3—diagnostic mode
- Port 4—alarm state
- Ports 5 through 8—out of service

Administrators can activate or deactivate individual ports, or place them in diagnostic mode. To do this, type **P**, for Port Definition, in the Card Maintenance screen's command field, then indicate the location of the card (R,L,S). When the card ports are displayed, one of the following port states can be designated: ACTIVE (**1**), OOS (**0**), or DIAG (**D**). Refer to *Table 1.3* for a definition of the port states and Figure 1.4 for a sample Card Maintenance and port state screen display.

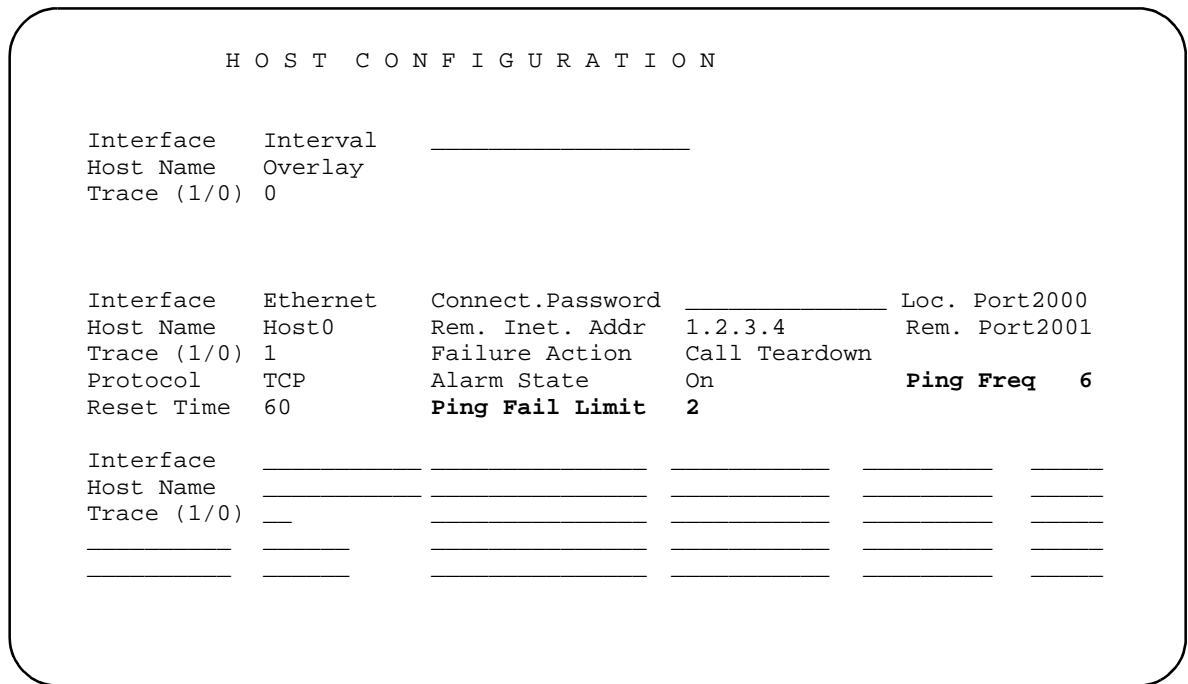
Figure 1.7: Host Configuration Screen

When the host is configured with *Ethernet* from the Host Configuration Screen, the user enters the probe frequency and number of failed probes to facilitate this feature. There are two new fields in the Host Configuration Screen. Refer to *Figure 1.7* and note the new fields which are illustrated in bold type.

The **Ping Frequency** field defines the time in seconds between probes. The range for this field is 0 to 60. The default for this field is zero (0), which indicates that probing will occur as it did prior to this enhancement—once every minute.

The **Ping Fail Limit** defines the number of consecutive failed probes to determine that a connection is lost. The range for this field is 0 to 10.

In the sample screen in *Figure 1.7*, the probe frequency is set to 6 seconds and the number of failed probes is set to 2. This means that the system will probe the remote host every 6 seconds and the switch will determine that a connection is lost when there is no response from 2 consecutive probes. This configuration defines a 12 second time frame for failure detection.

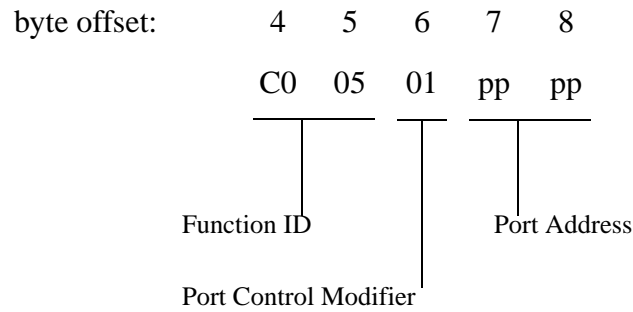
Figure 1.9: \$C0 05 Command Format Prior to V3.3 FSR06

Prior to this release, the \$C0 05 command operated as shown in Figure 1.9.

(\$C0 05)      **Host Assume/Relinquish Port Control**

Function ID (byte offset 4 & 5) - Bytes immediately following the Network Header; uniquely identifies the command to the system.

Port Control Modifier (byte offset 6) - Determines the type of action to be taken. Specify this byte according to the following list:

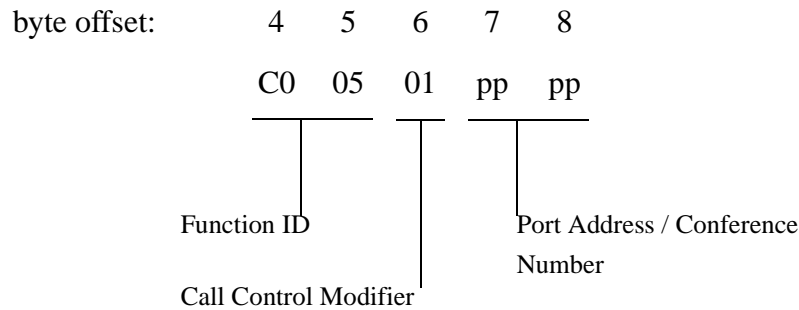
Figure 1.10: New \$C0 05 Command Format

The new command format is shown in Figure 1.10.

(\$C0 05)      **Host Assume/Relinquish Port and Conference Control**

Function ID (byte offset 4 & 5) - Bytes immediately following the Network Header; uniquely identifies the command to the system.

Call Control Modifier (byte offset 6) - Determines the type of action to be taken.

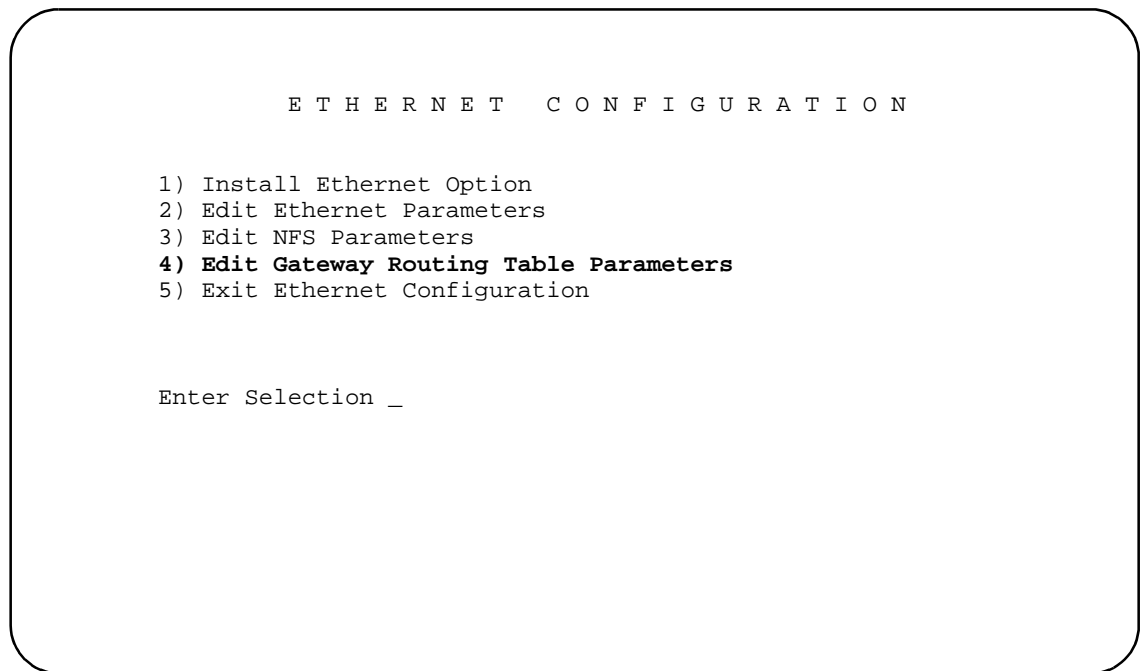
Figure 1.11: Ethernet Configuration Screen with Gateway Menu Option

The Ethernet Configuration menu has been modified as shown in Figure 1.11 to add Gateway Routing.

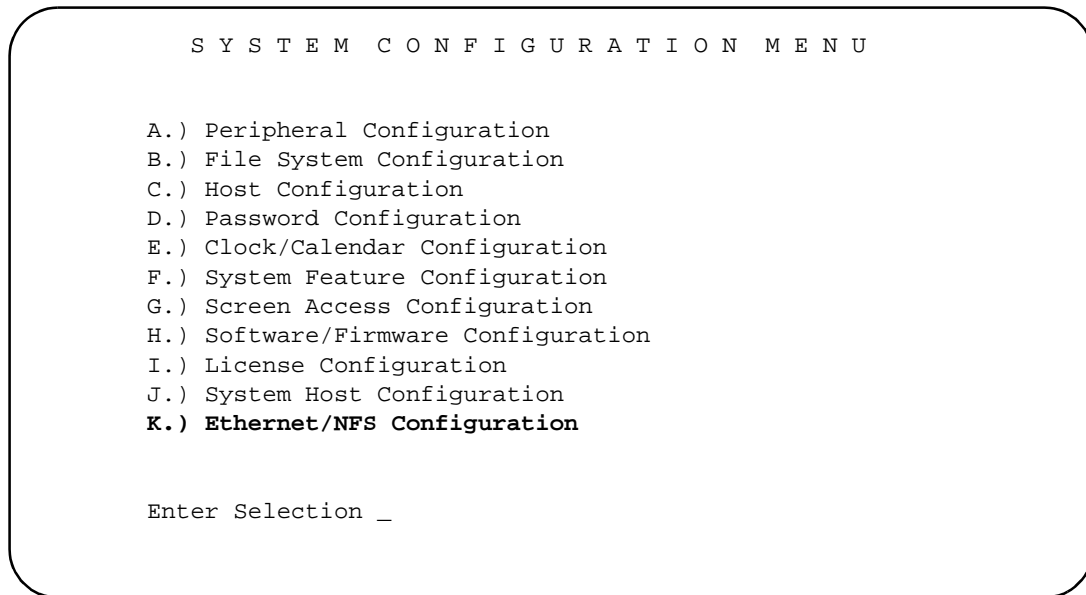
Figure 1.12: System Configuration Menu

The System Configuration Menu has been extended to include a new option, K, for Ethernet/NFS configuration. Refer to Figure 1.12.

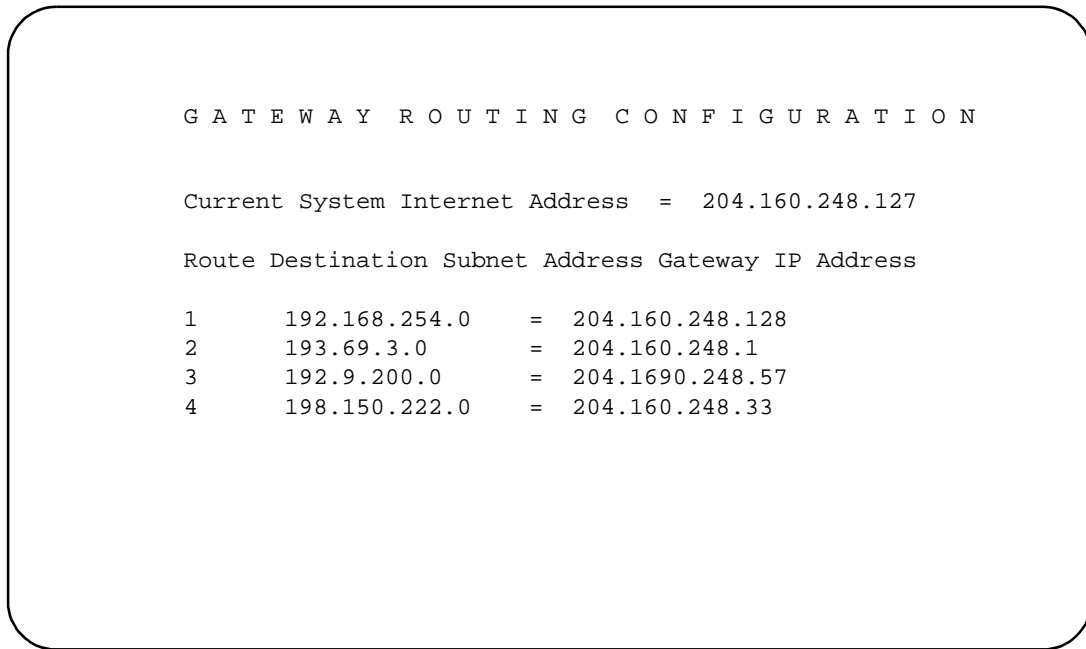
Figure 1.14: Gateway Routing Configuration Screen

The Gateway Routing Configuration screen has one display-only field, the Current System Internet Address field (copied down from the parent Ethernet/NFS Configuration screen), and eight variable fields for Internet address entries. The variable fields correspond to four supported gateways. Refer to Figure 1.14.

To bring up the Gateway Routing Configuration screen, place the cursor at the data entry field for Gateway Routing Configuration in the Ethernet/NFS Configuration screen, enter a non-null character, and press **Enter**.

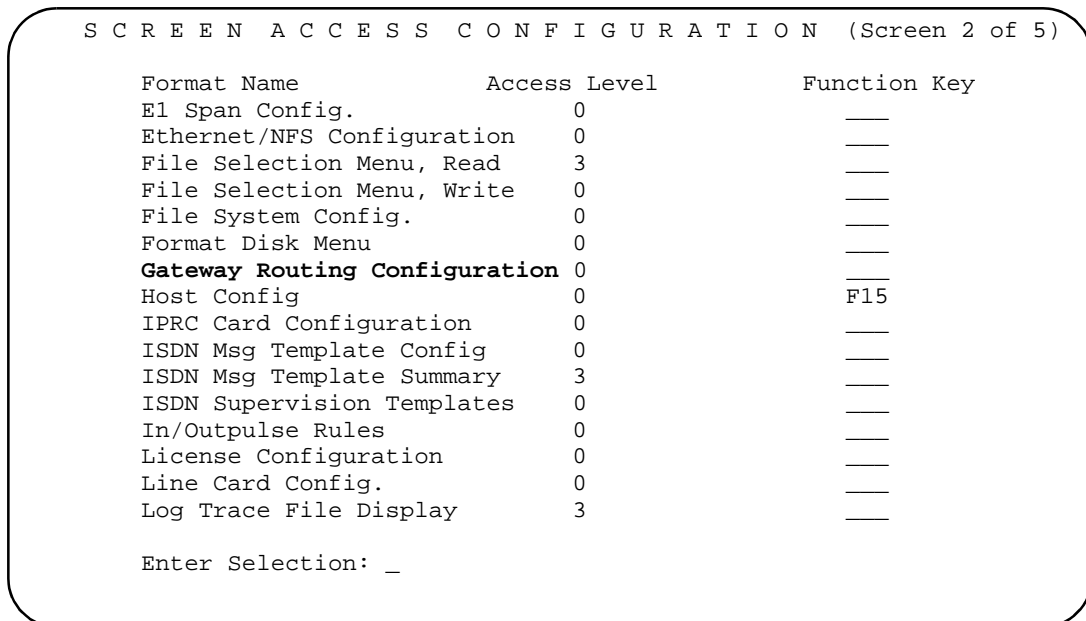
Gateway Routing configuration is under access control. When a user chooses Option G from the System Configuration Menu to bring up the Screen Access Configuration screen, a new line for Gateway Routing Configuration appears on the second of five screens. Valid access level entries are from 0 to 3. The default is 0 (full access). Refer to Figure 1.15.

```
S C R E E N   A C C E S S   C O N F I G U R A T I O N   (Screen 2 of 5)

Format Name                Access Level                Function Key
E1 Span Config.            0                            ___
Ethernet/NFS Configuration 0                            ___
File Selection Menu, Read  3                            ___
File Selection Menu, Write 0                            ___
File System Config.        0                            ___
Format Disk Menu           0                            ___
Gateway Routing Configuration 0                            ___
Host Config                 0                            F15
IPRC Card Configuration    0                            ___
ISDN Msg Template Config   0                            ___
ISDN Msg Template Summary  3                            ___
ISDN Supervision Templates 0                            ___
In/Outpulse Rules          0                            ___
License Configuration       0                            ___
Line Card Config.          0                            ___

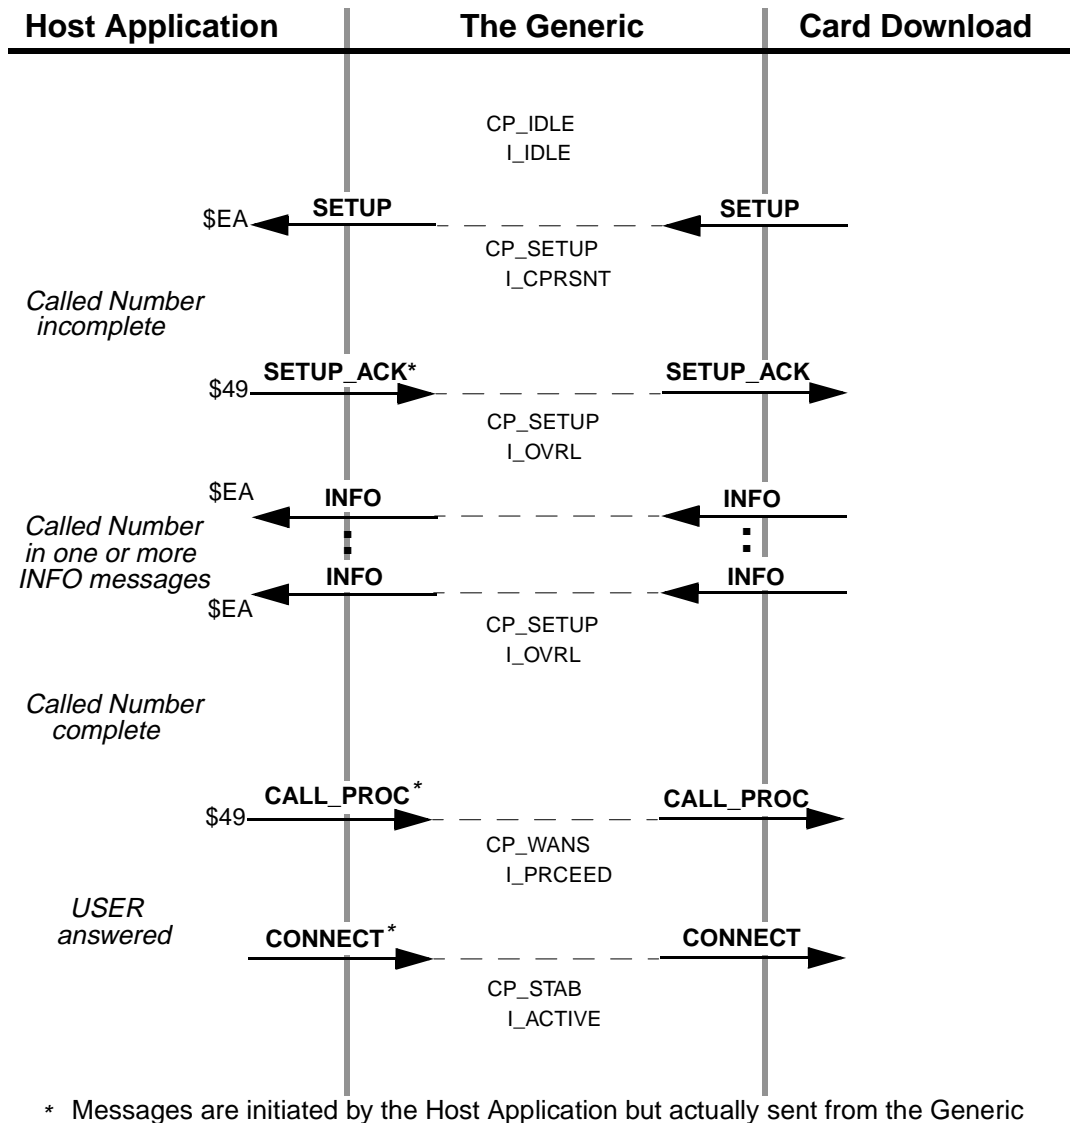
Figure 1.17: Overlap Receiving with Indication (SETUP\_ACK) from Host Application

The Generic considers this as an indicator of the end of Overlap Receiving and I\_PROCEED state is entered. Refer to Figure 1.17.

Note that in Figure 1.17, the \$EA report, not the \$ED report, is sent to the Host Application for the SETUP message.

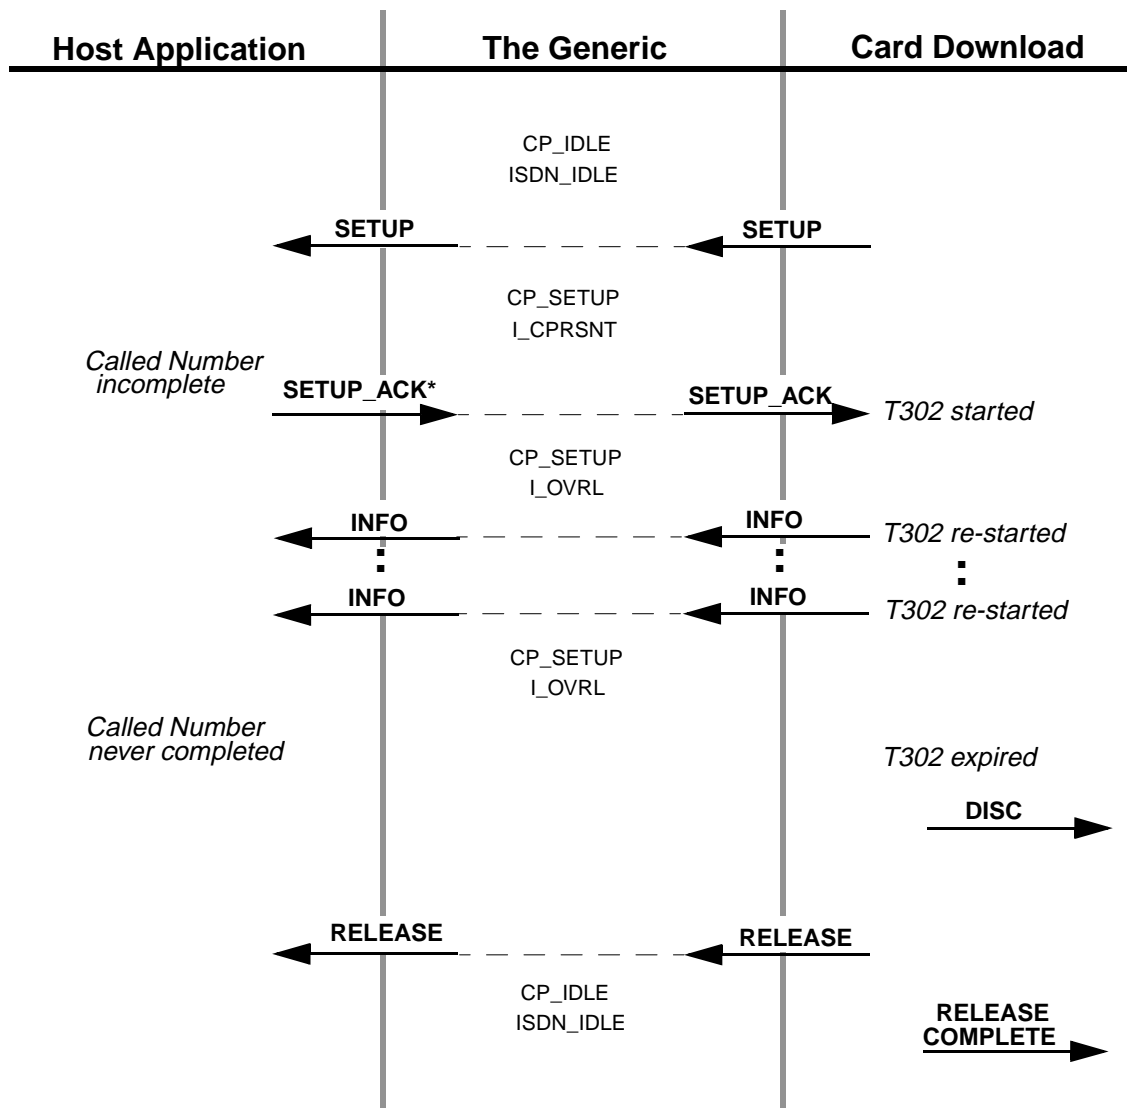
Figure 1.18: T302 Expiry and Call Clearing from the Card Download

Figure 1.18 shows the T302 expiry and call clearing processing initiated by USER. The first call clearing message is RELEASE from NETWORK.

\* Messages are initiated by the Host Application but actually sent from the Generic

The system uses a timer (T302) when in Overlap Receiving to control call clearing (aborting). Refer to Figure 1.18. The timer resides in, and is controlled by, the card download.

- Overlap Receiving operation is ended and the card download sends out DISC to the Network. At this point, there is no report of DISC from the card download to the Generic.
- The Network responds to DISC by sending back RELEASE, which is passed to the Generic and the Host Application.
- Call context at the Generic and the Host Application is cleared.
- The card download sends out REL\_COMPL to the Network to complete the call clearing.
- The CAUSE IE with outgoing DISC for this call clearing is #28: Invalid Number Format (incomplete number).

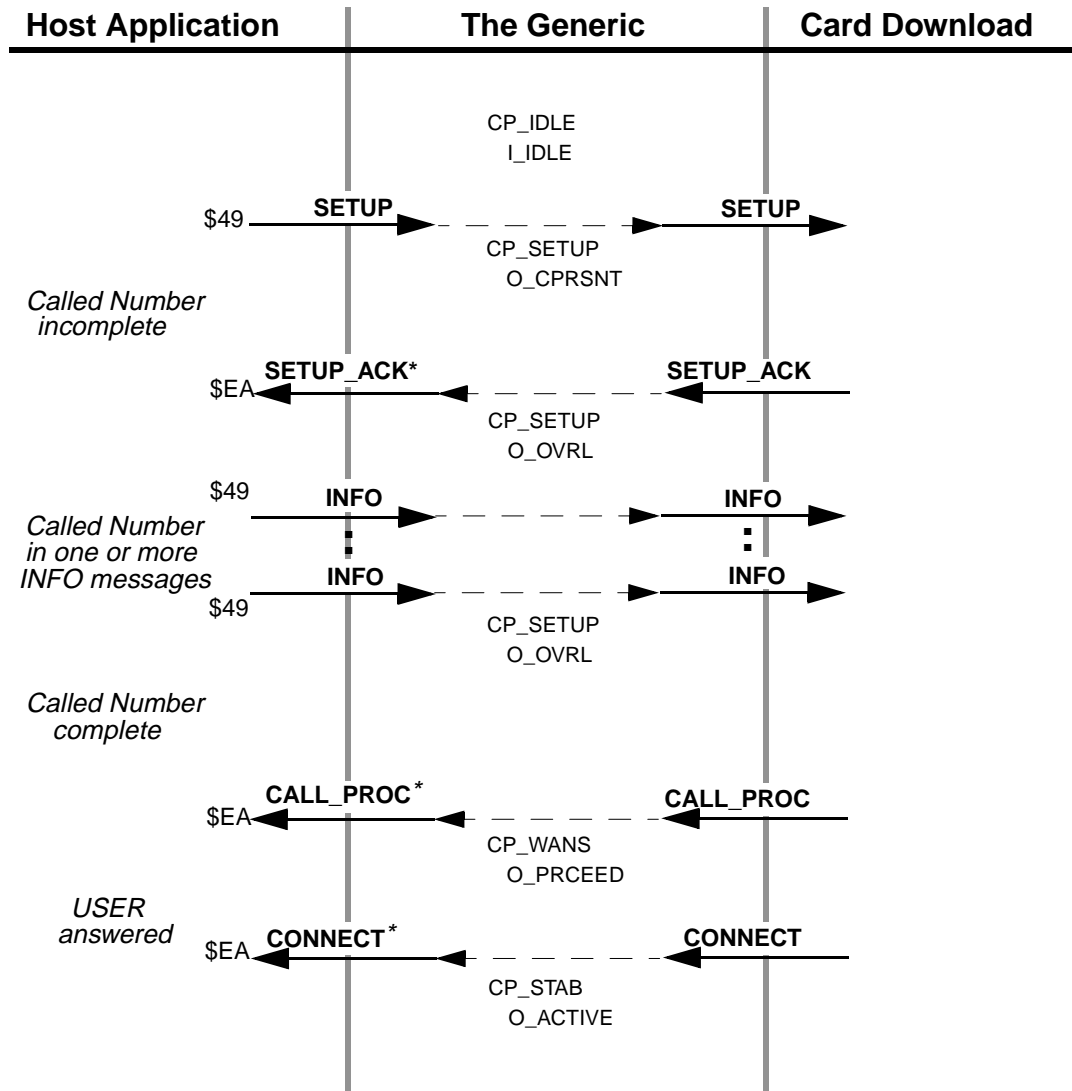
Figure 1.19: Overlap Sending with Indication (SETUP\_ACK) to Host Application

The Generic considers this as an indicator of the end of Overlap Sending and O\_PROCEED state is entered. Refer to Figure 1.19.

\* Messages are initiated by the Host Application but actually sent from the Generic

Note that in Figure 1.19, the \$49 report, not the \$ED report, is sent to the Host Application for the SETUP message.

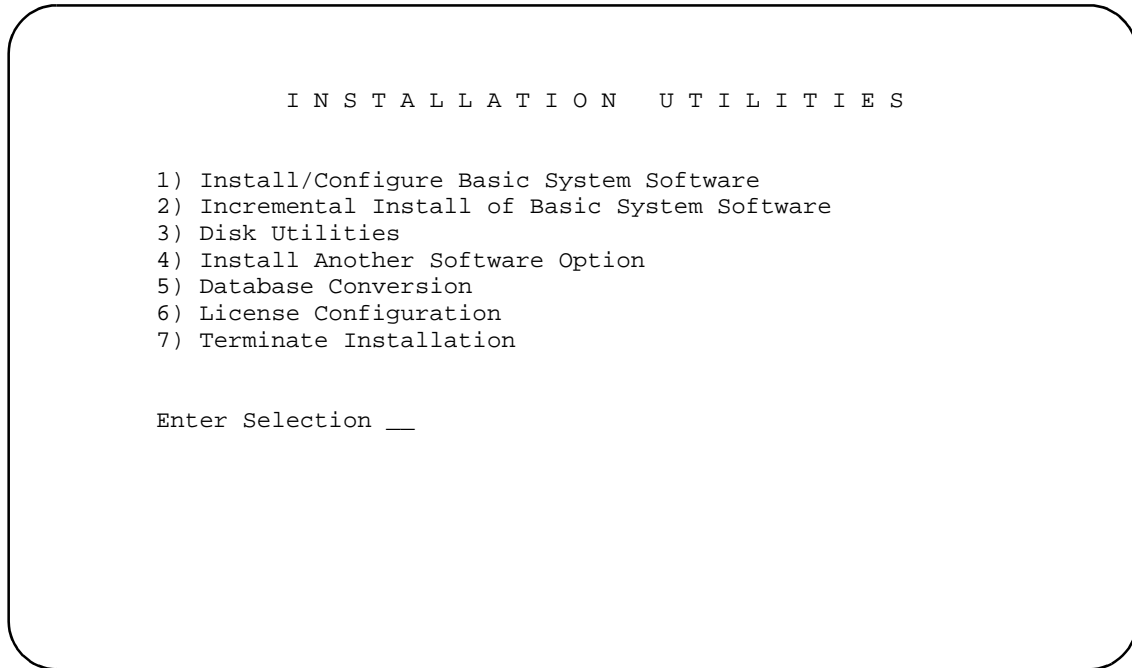
Figure 3.1: Installation Utilities Menu

1. Insert Disk 1 into the A-side floppy drive.
2. Power up the A-side. After the system performs diagnostic tests, the Installation Utilities menu appears (Figure 3.1).

Remove the current diskette from the drive, insert Disk 4 and press **Return**. When the installation is complete, the Installation Utilities menu appears (Figure 3.1).

1. Power up the A-side.
2. Insert Disk 1 in the A-side drive.
3. After the system performs diagnostic tests, the Installation Utilities menu appears (Figure 3.1).
4. To install a software option, type **4** and press **Return**. The following message appears:

1. Access the Installation Utilities menu (Figure 3.1).
2. Insert a high-density diskette into the floppy drive.
3. Type **3** and press **Return**. The Disk Utilities menu appears (Figure 3.3)

1. Access the Installation Utilities menu (Figure 3.1).
2. Insert the diskette containing the backed up data base tables into the floppy drive.
3. Type **3** and press **Return**. The Disk Utilities menu appears (Figure 3.3).
4. Type **2** and press **Return**. The following message appears:

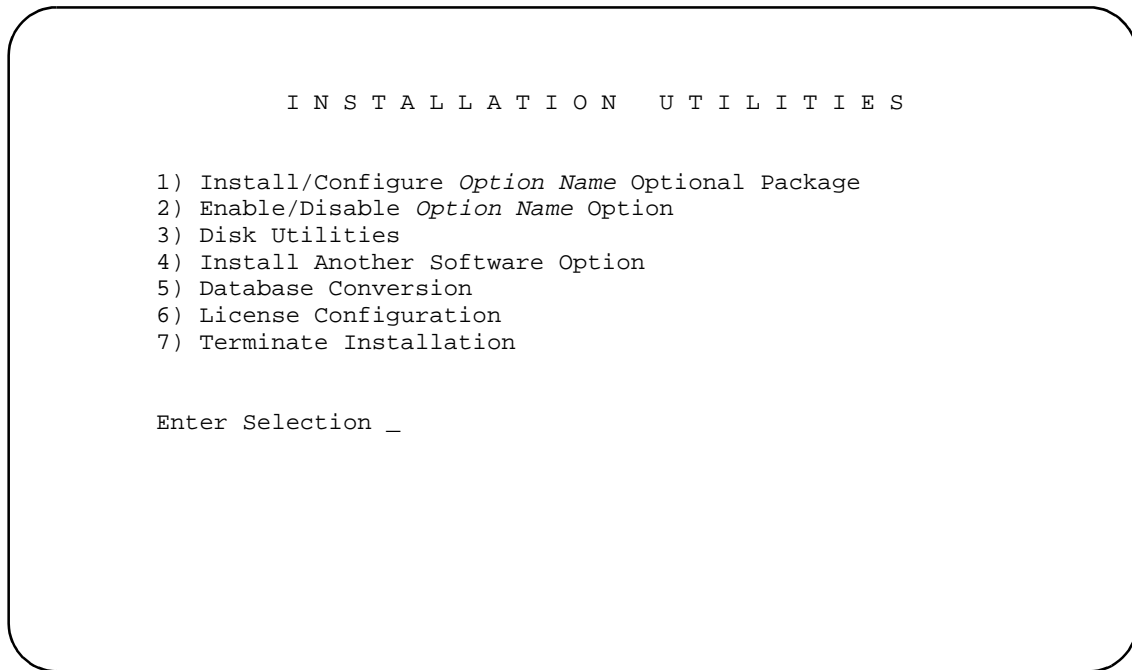
Figure 3.2: Optional Software Installation Utilities Menu

5. Remove the current diskette from the drive, insert the optional software diskette and press **Return**. The Installation Utilities menu specific to the software option appears (Figure 3.2).

*NOTE: The optional software being installed appears in selections 1 and 2 on the Optional Installation Utilities menu in place of Option Name.*

7. a. If you do not wish to back-up the system data base, press **Return** and proceed to Step 7a (in this section).
- b. To back-up the data base, type **Y** and press **Return**. The installation is aborted and the optional Installation Utilities menu appears (Figure 3.2). Instructions for backing up the system data base are provided in *Section 3.6.1*.

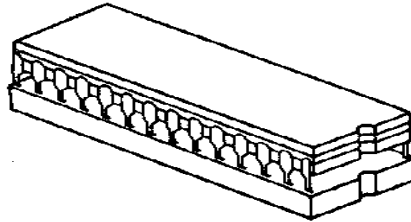
Figure A.4: Inserting Pins in Other Side of Socket

4. Insert the pins on the other side of the PROM or PLD chip into holes on that side of the socket (see Figure A.4).

*NOTE: If the pins are not aligned with the socket holes, remove the PROM or PLD chip and straighten the pins (see Step 1). After realigning the pins, repeat Step 2 through Step 4.*

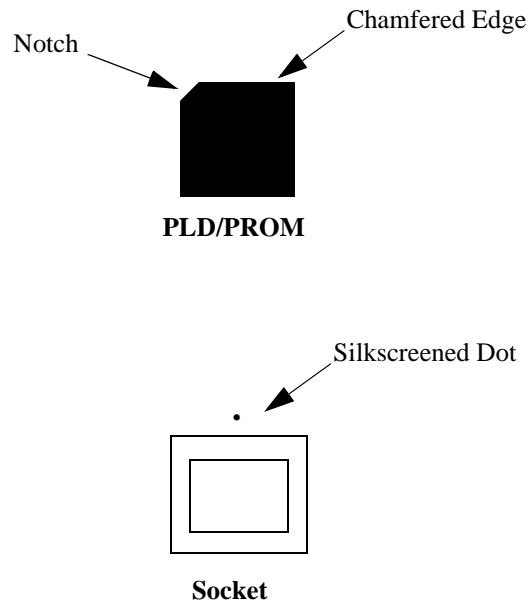
Figure A.5: PLD Alignment

1. Before installing the new PROM or PLD, verify that the pins are all evenly spaced and properly aligned. If necessary, use tweezers to carefully align the IC pins prior to installation.
2. Align the notch or chamfered edge on the PROM or PLD to the silkscreened dot on the circuit card (see Figure A.5).

3. With all pins aligned to the pins of the socket, apply gentle, even finger pressure to the top of the chip until it is fully seated in its socket. This completes the installation of the surface mount chip.
4. With all the pins inserted into the socket, apply gentle and even pressure to the top of the chip until it is fully seated in the socket.
5. Reinstall the circuit card in the system or return the card to spares stock.
