**Generic V5.0
FSR00 PUN24
Release Notes**

61220300050-09P

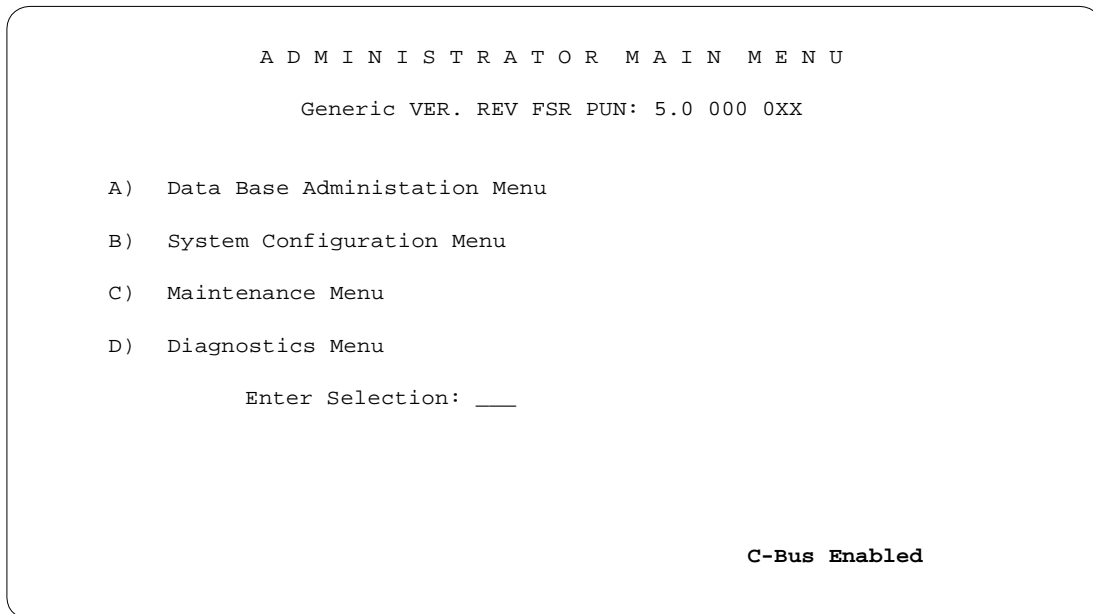
Figure 2.4: Administrator Main Menu Screen

The Administrator Main Menu screen (see *Figure 2.4*) displays a message if C-bus is enabled. If C-bus is installed and the hardware is detected, a C-Bus Enabled message appears on the lower right corner of the screen. However, in the unusual event that the hardware is not detected, a C-Bus ERROR message displays.

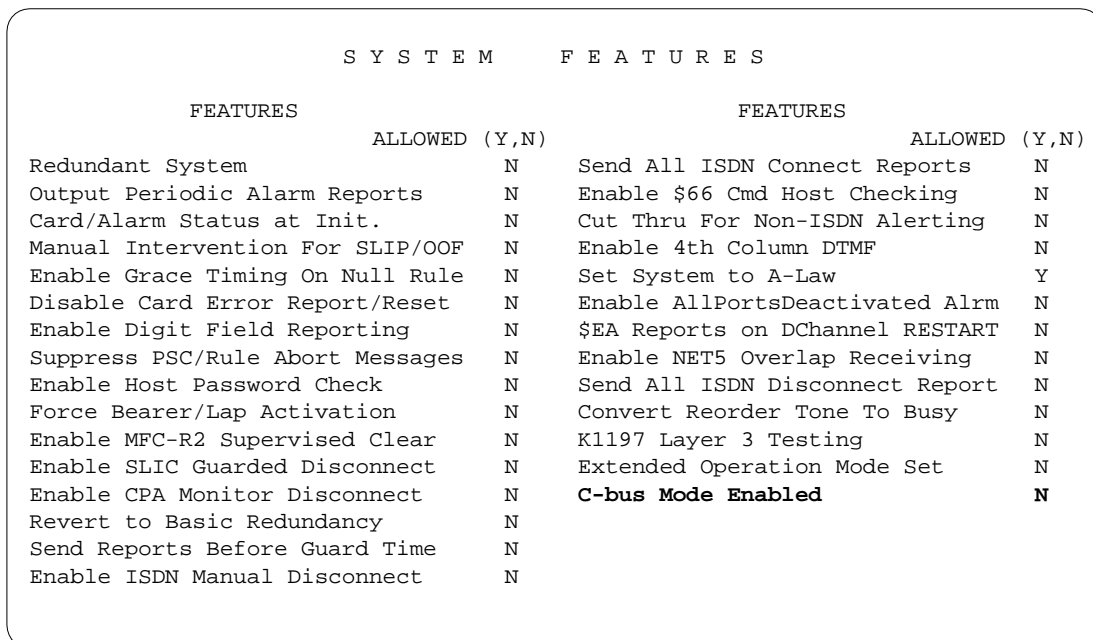
Figure 2.5: C-bus Mode Verification Flag

A C-Bus Mode Enabled flag is added to the System Features screen, as shown in *Figure 2.5*. This flag is read-only and is used to verify if the C-bus is enabled. If Y, C-bus is enabled, and your switch can take advantage of the 4000 ports. If N, C-bus is disabled, and your system is limited to approximately 2000 ports.

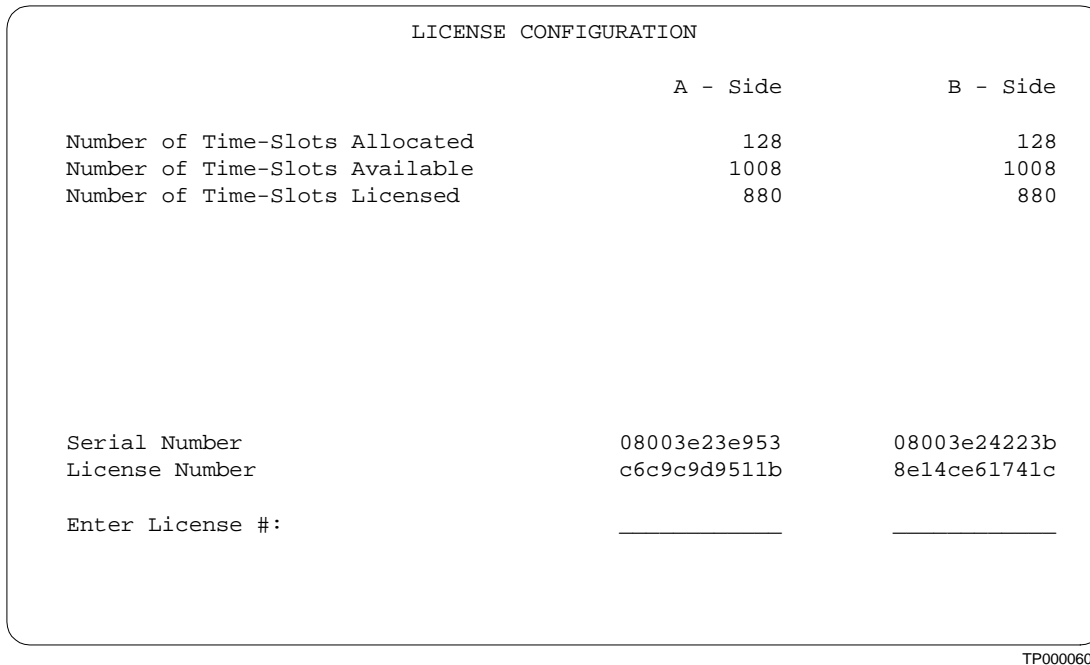
Figure 2.7: License Configuration Screen

The License Configuration screen has changed to better reflect the timeslot information that is displayed at the bottom of the main menu and Card Maintenance screens. See *Figure 2.7* for a sample of the new screen.

The number of timeslots licensed refers to the actual number of purchased timeslots. The number of timeslots available may be more or less than the number of timeslots licensed for the following reasons:

- A 2K system may have more than 2000 timeslots licensed. The maximum number of timeslots available in a 2K system is 1936.
- The DTG timeslots are “free.” The number of timeslots available is adjusted upward to reflect the free DTG timeslots.

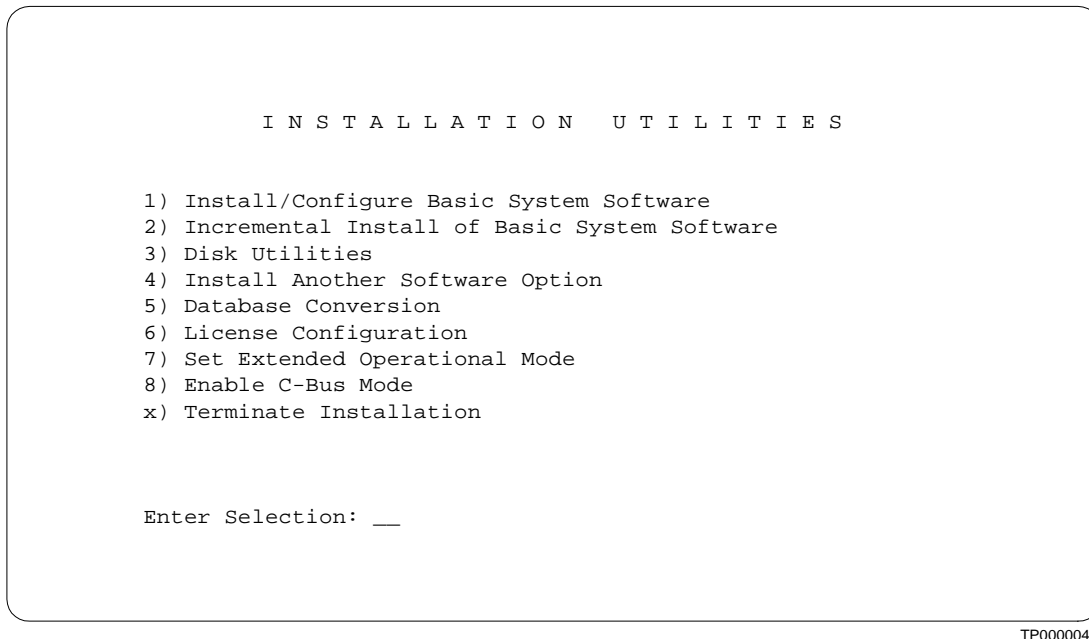
Figure 4.1: Installation Utilities Menu

1. Insert Disk 1 into the floppy diskette drive (A-side if this is a non-redundant system, B-side if you are returning to this procedure to install software for that side).
2. Connect or switch the administration console to the A-side CPU-TM, or go to the A-side system console.
3. Power on the A-side.
4. After the system performs diagnostic tests, the Installation Utilities menu appears (*Figure 4.1*).
5. The cursor is located in the Enter Selection data entry field. Type **2**, (for Incremental Install of Basic System Software) then press **Return**.

Do You Wish To Back-Up The System Data Base? (Y/N) =N?_

When the installation is complete, the Installation Utilities menu appears again (Figure 4.1).

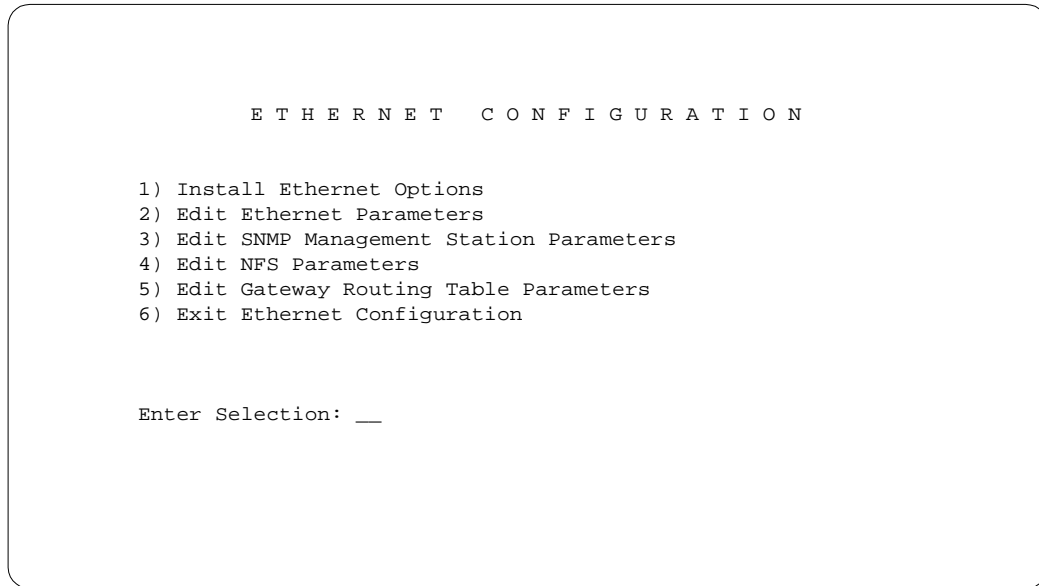
Figure 4.3: Ethernet Configuration Menu

The Ethernet Configuration menu appears (see *Figure 4.3*).

NOTE: The Ethernet and Internet address numbers that you see in the screen messages in this section are only examples. In your system these numbers are replaced by numbers that represent your system addresses.
